# Manhole Inspection Summary

Manhole # S47C2\_001MH

Insp Date: **1/28/08 10:31 AM**

**Location** Address: **3901 Curtis Ave**

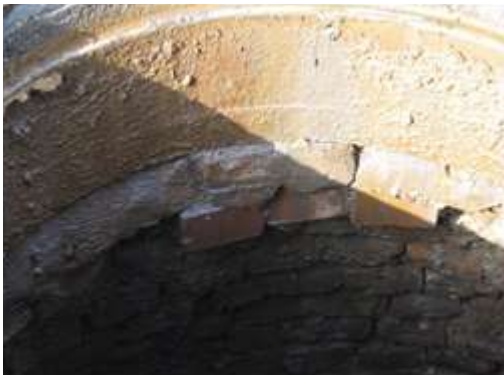
Defect 1

Condition: ☐ Sound ☐ Cracked ☐ Root Intrusion ☒ **Loose Brick** ☐ Deteriorated

Infiltration: ☐ None ☒ **Joint** ☐ Cracks ☐ Mortar ☐ Roots ☒ **Wall**

Chimney

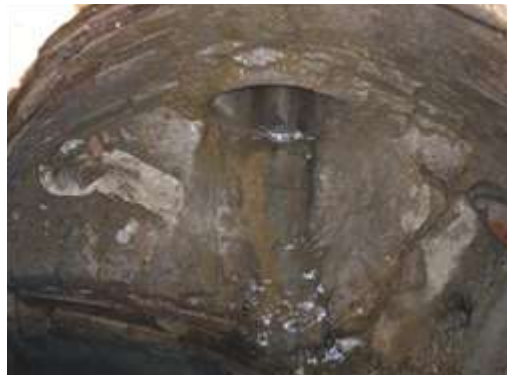
Defect 2

Debris

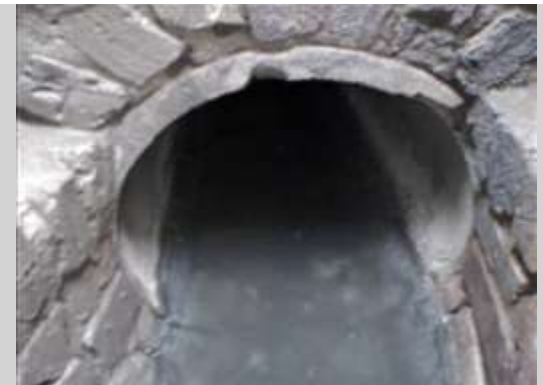
3 O'Clock Inflow

15 in. Circular Gravity Sewer  
Pipe In @ 3 O'Clock

Pipe Height: **15.6** (in.) Rod and Bar (Angled)  
Pipe Material: **Clay** ☐ Pipe Lined  
Invert Depth: **5.09** (ft.) Flow Characteristics: **Fast**  
Deposits: ☒ None ☐ Mud ☐ Sludge ☐ Debris ☐ Grease  
Silt Depth: (in.) Deposits Extent:  
Infiltration: **None** Pipe Seal Cond: **Cracked**

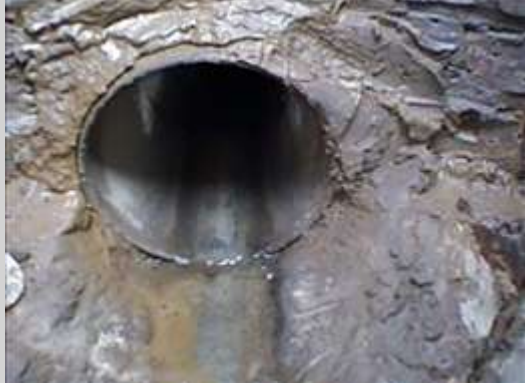
6 O'Clock Inflow

Pipe In @ 6 O'Clock

Infiltration: **None** Pipe Seal Cond: **Broken**
